O Gauge G P Keen 4-6-2 Compound Pacific No 6000 – Before Restoration

O Gauge electric 3-Rail Coarse Scale 4-6-2 Compound Pacific no. 6000 made by G P Keen

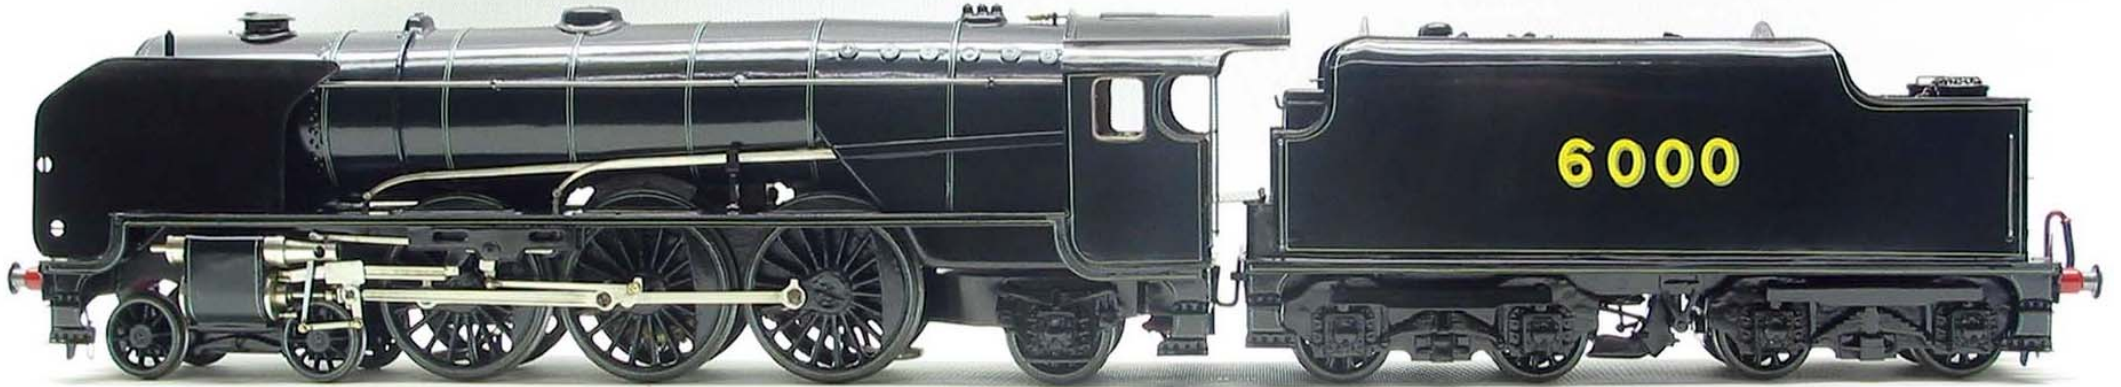
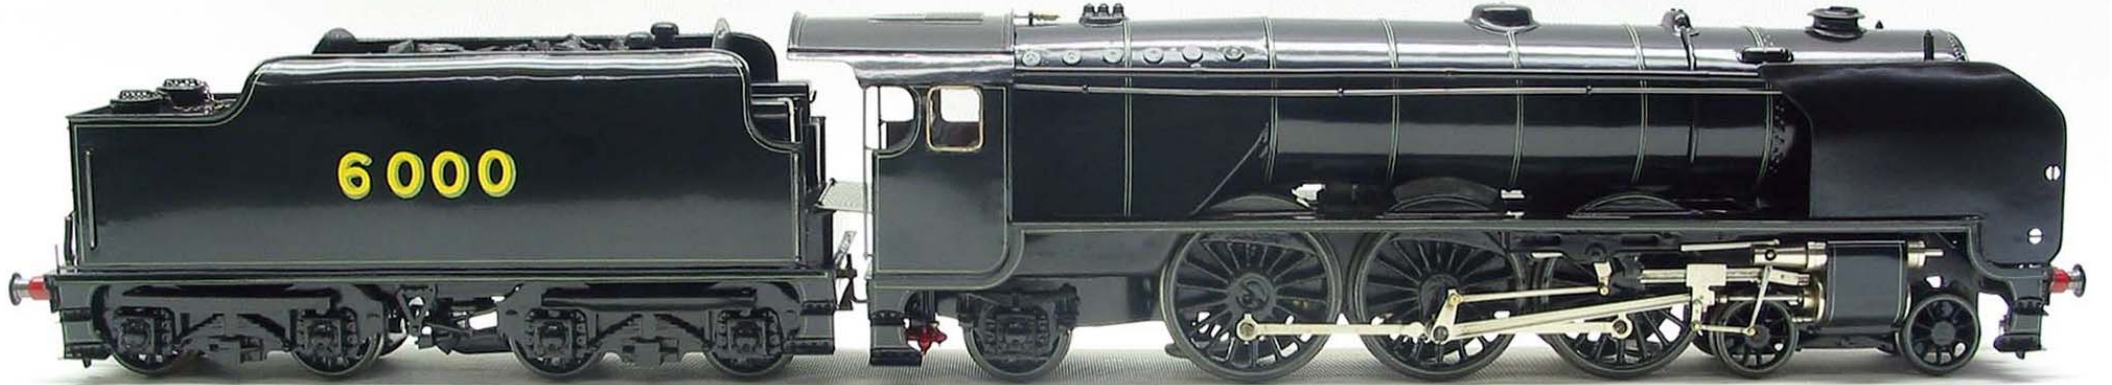
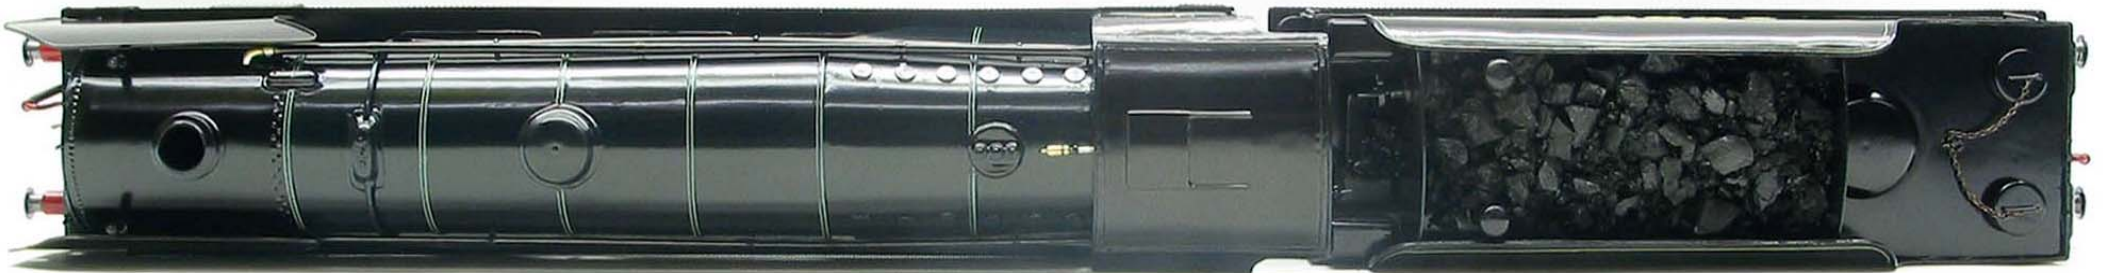
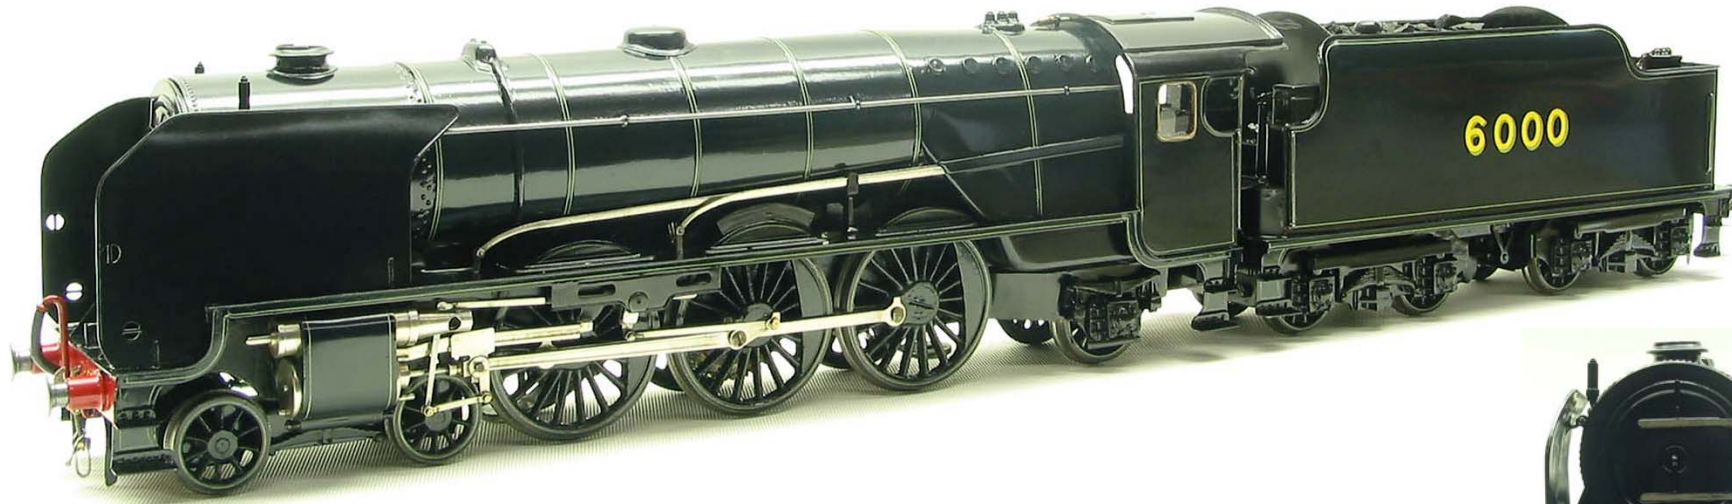
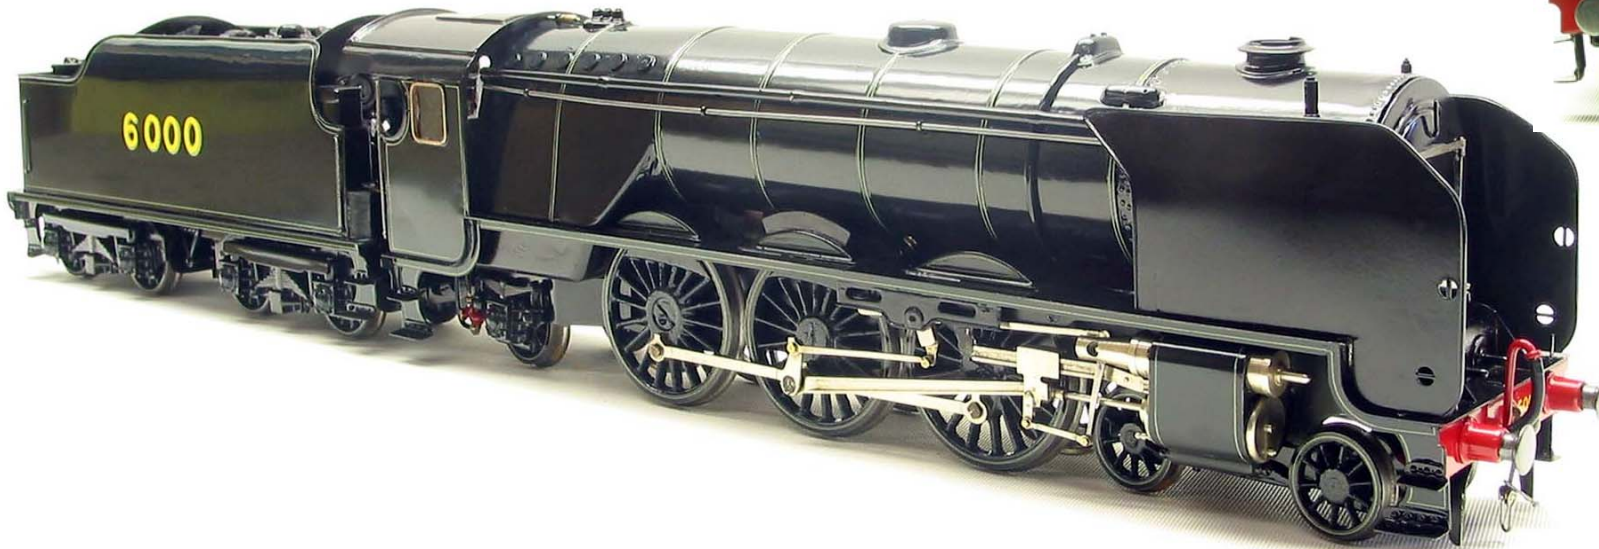
O Gauge G P Keen 4-6-2 Compound Pacific No 6000 – After Restoration

Restoration by Simon Greenwood
